LEVEL 1 DOWNSTREAM ANALYSIS

Champagne Creek (Class B Stream)

Kirkland Cottages 7845 NE 122nd Place Kirkland, WA 98034

Tax Map #607650-0421 February 25, 2016 CES #1430

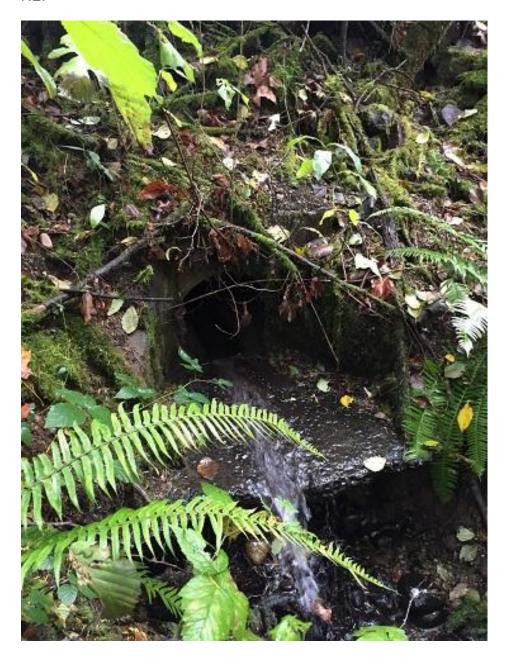
<u>Picture 1</u>: 18" concrete pipe outlet in Juanita Triangle Park going under Juanita Drive NE.

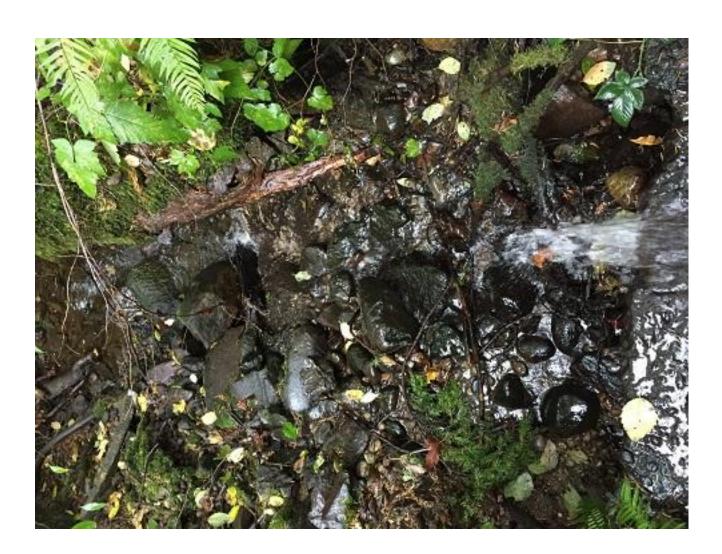
Picture 2: Same discharge, water discharging out of 18" culvert pipe

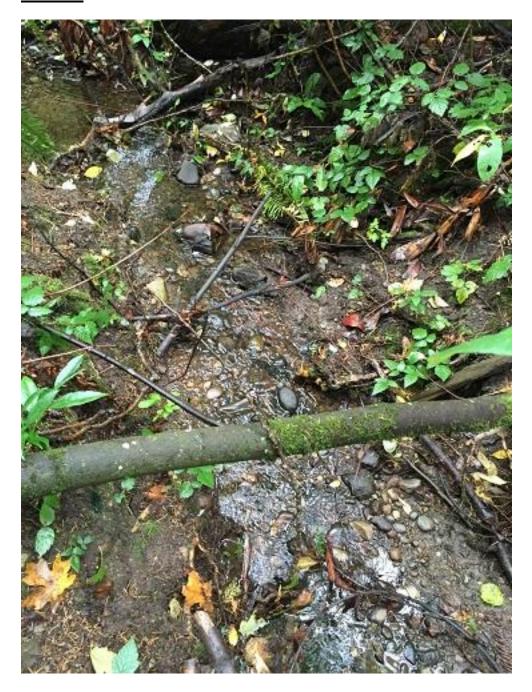
Picture 4: Stream bed thru Juanita Woodlands Park.

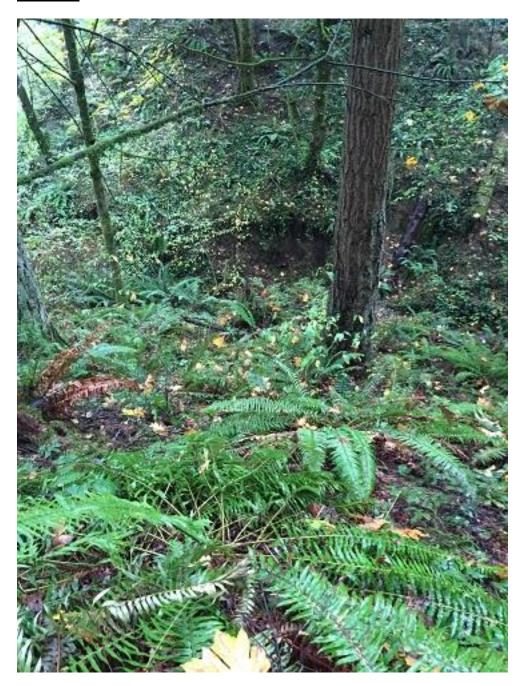
<u>Picture 5</u>: Stream thru Juanita Woodlands Park.

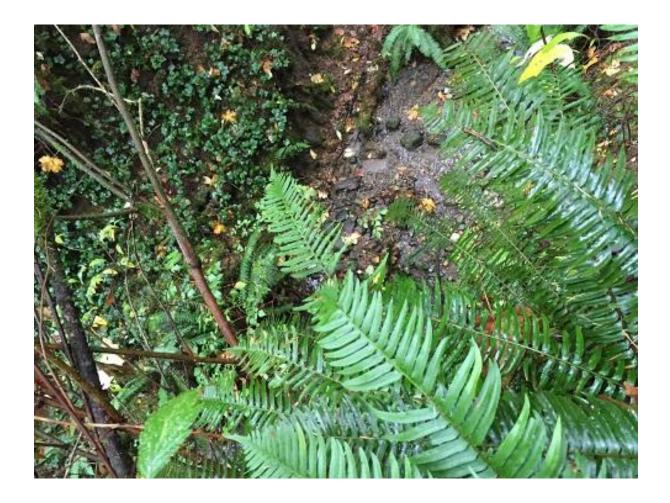
<u>Picture 6</u>: Stream bed thru Juanita Woodlands Park.

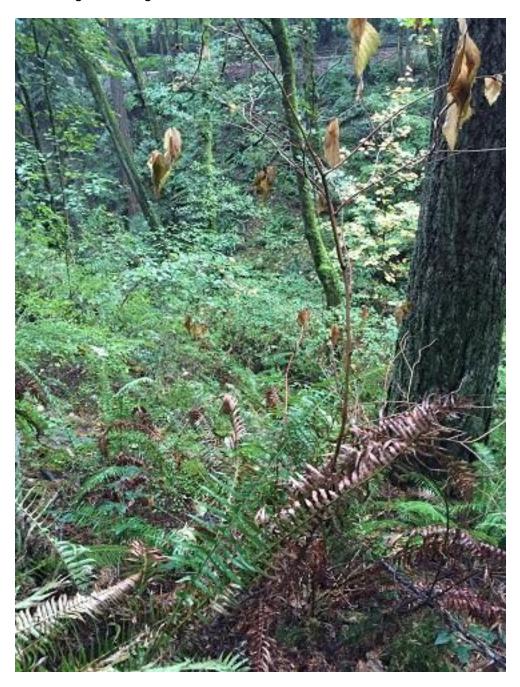
<u>Picture 7</u>: Looking across the creek with street in background, fairly heavily vegetated and no significant signs of erosion.

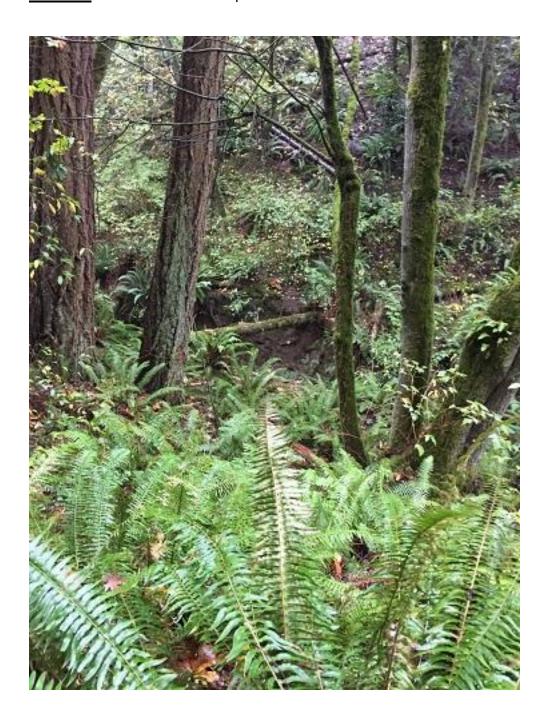
<u>Picture 8</u>: Further downstream picture of creek in Juanita Woodlands Park.
